**MATERIAL AND FLIGHT TEST**

**BALLOON TYPE 302-P****PERSONNEL CARRIER****PROJECT 209****UNDER****CONTRACT NONR 2484(00)**

**RAVEN INDUSTRIES, INC.**  
 Box 227  
 Sioux Falls, South Dakota

**PRELIMINARY INSPECTION**

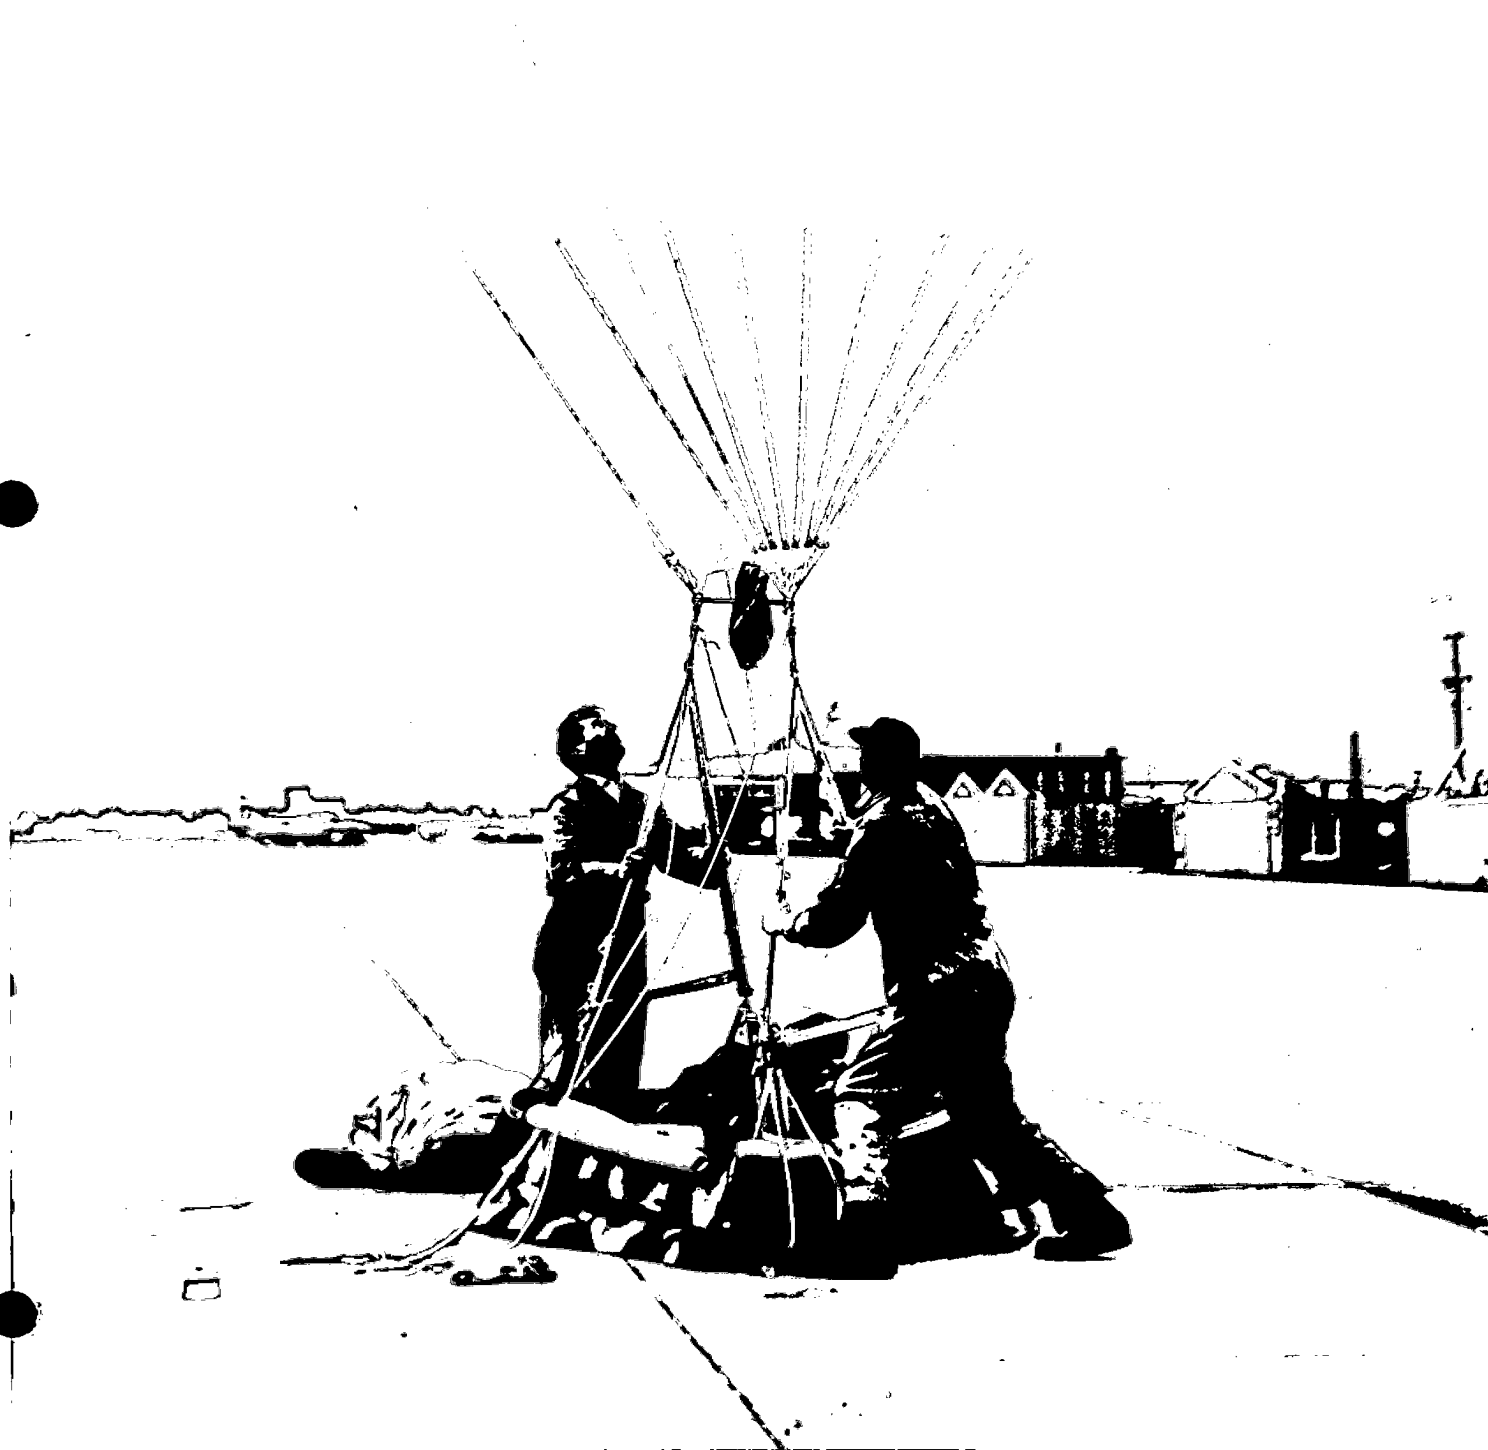
Figure 2.

The balloon was inflated (with gondola and load attached) to 924 pounds of lift. At this time, it was in a balanced or "weighed off" condition. The gondola was raised a few feet above the concrete ramp inflation area and manually forced downward against the ramp with considerable force. This action caused a reverberation throughout the balloon and created abnormal strains throughout the system. If any weak points existed in the balloon envelope it would have ruptured during this test. The "bouncing" test was continued two more times and then was considered satisfactory for flight.

Pre-Flight Bounce Test.

A pre-flight shock test on the flight line ( mentioned in Part II. ) is an added safeguard before each flight.

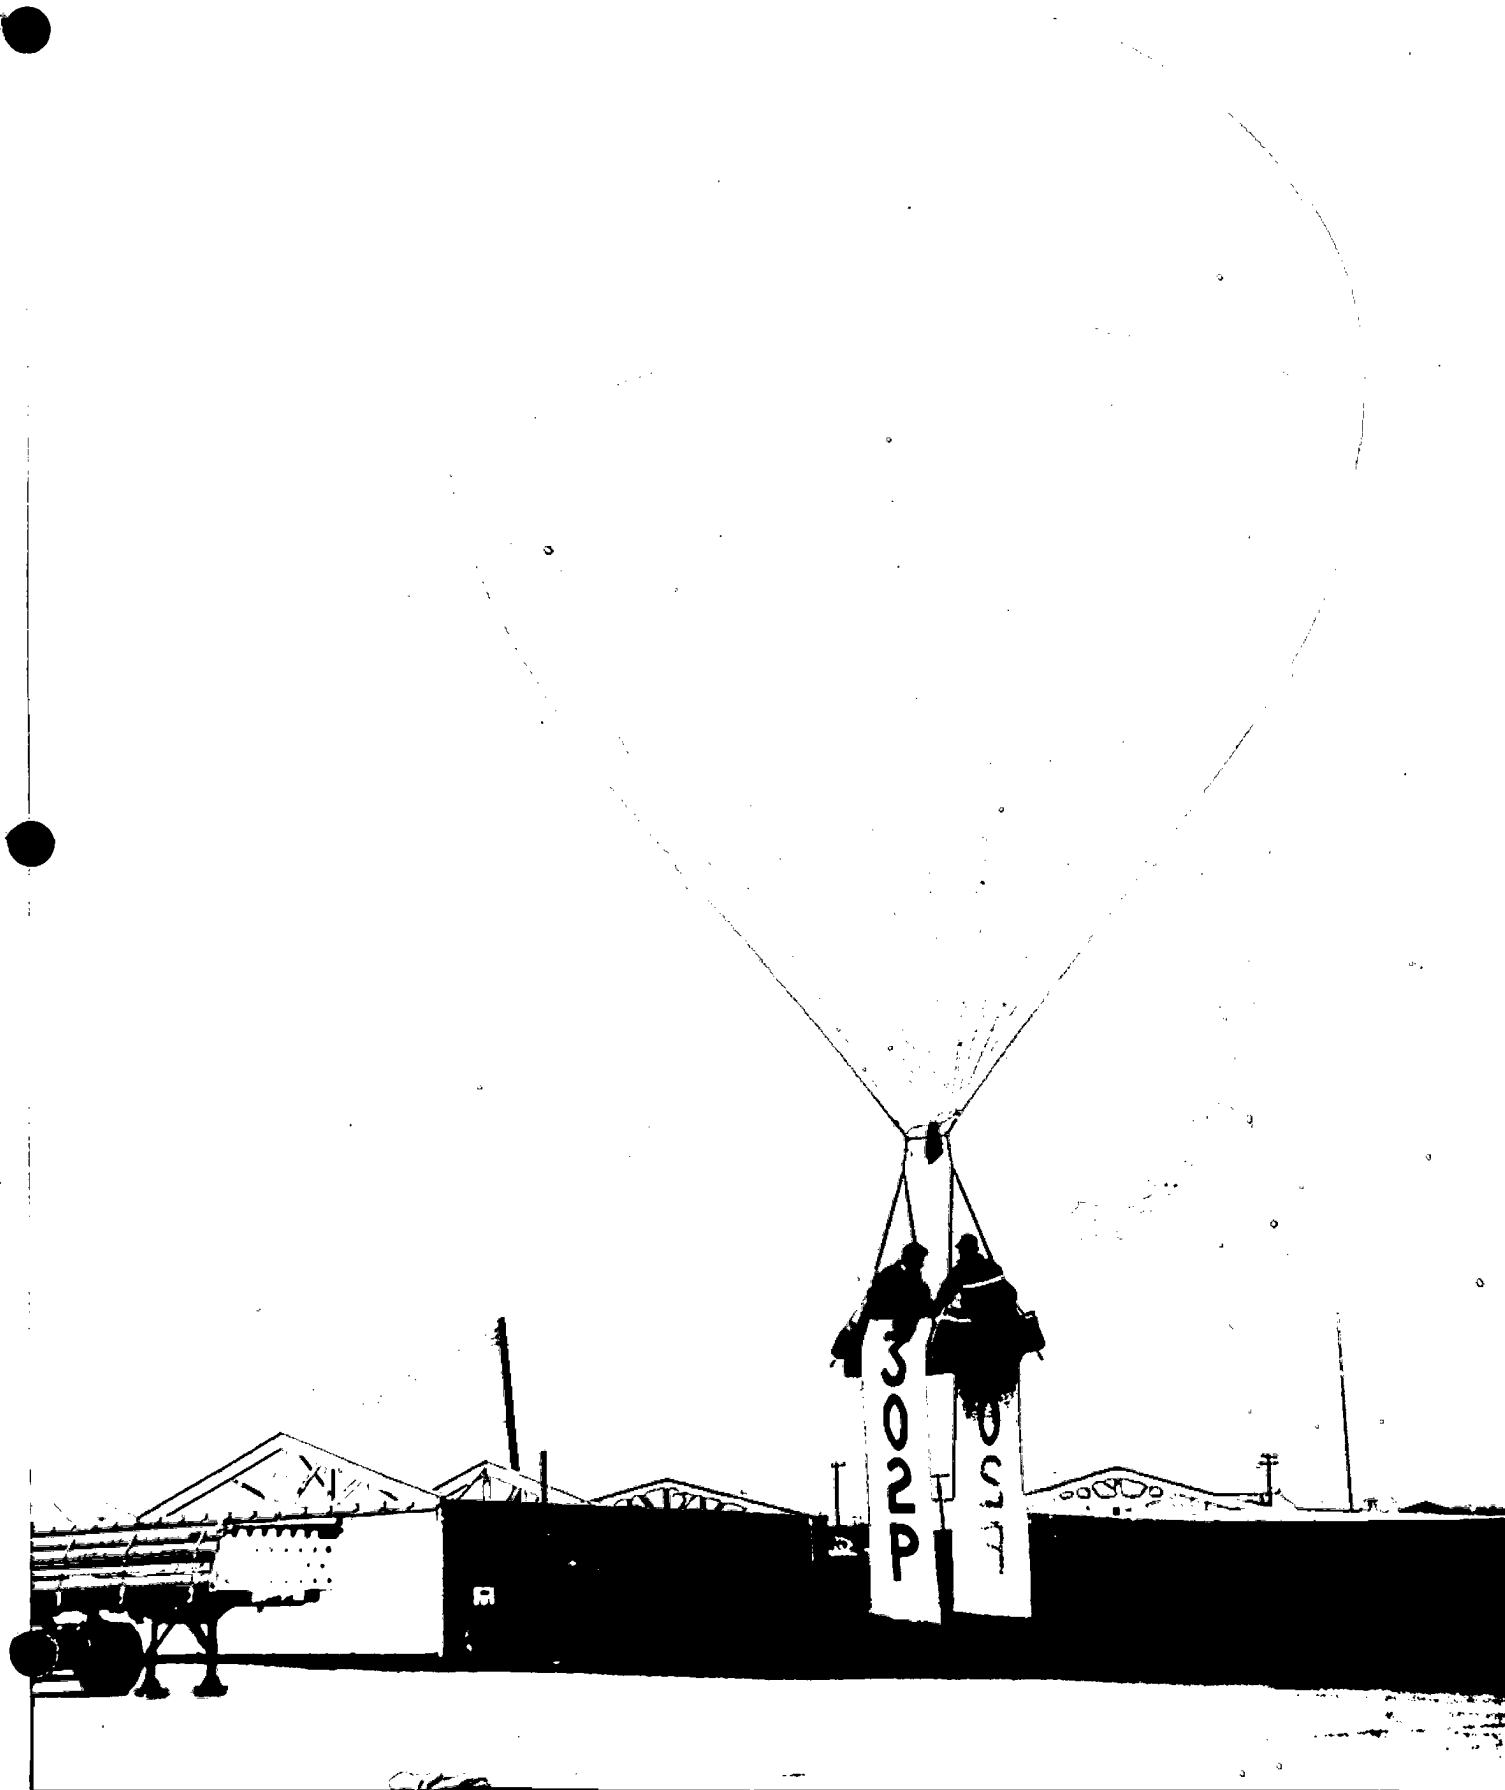
Figure 3.

At 0640 CST, the flight was airborne and a rate of rise of 250 feet per minute was maintained until reaching the floating altitude of 4500 feet m.s.l. (3000 feet above the terrain).

This floating altitude remained constant without ballast which indicates that no holes existed in the balloon envelope.

Balloon 302-P Shortly After Launch

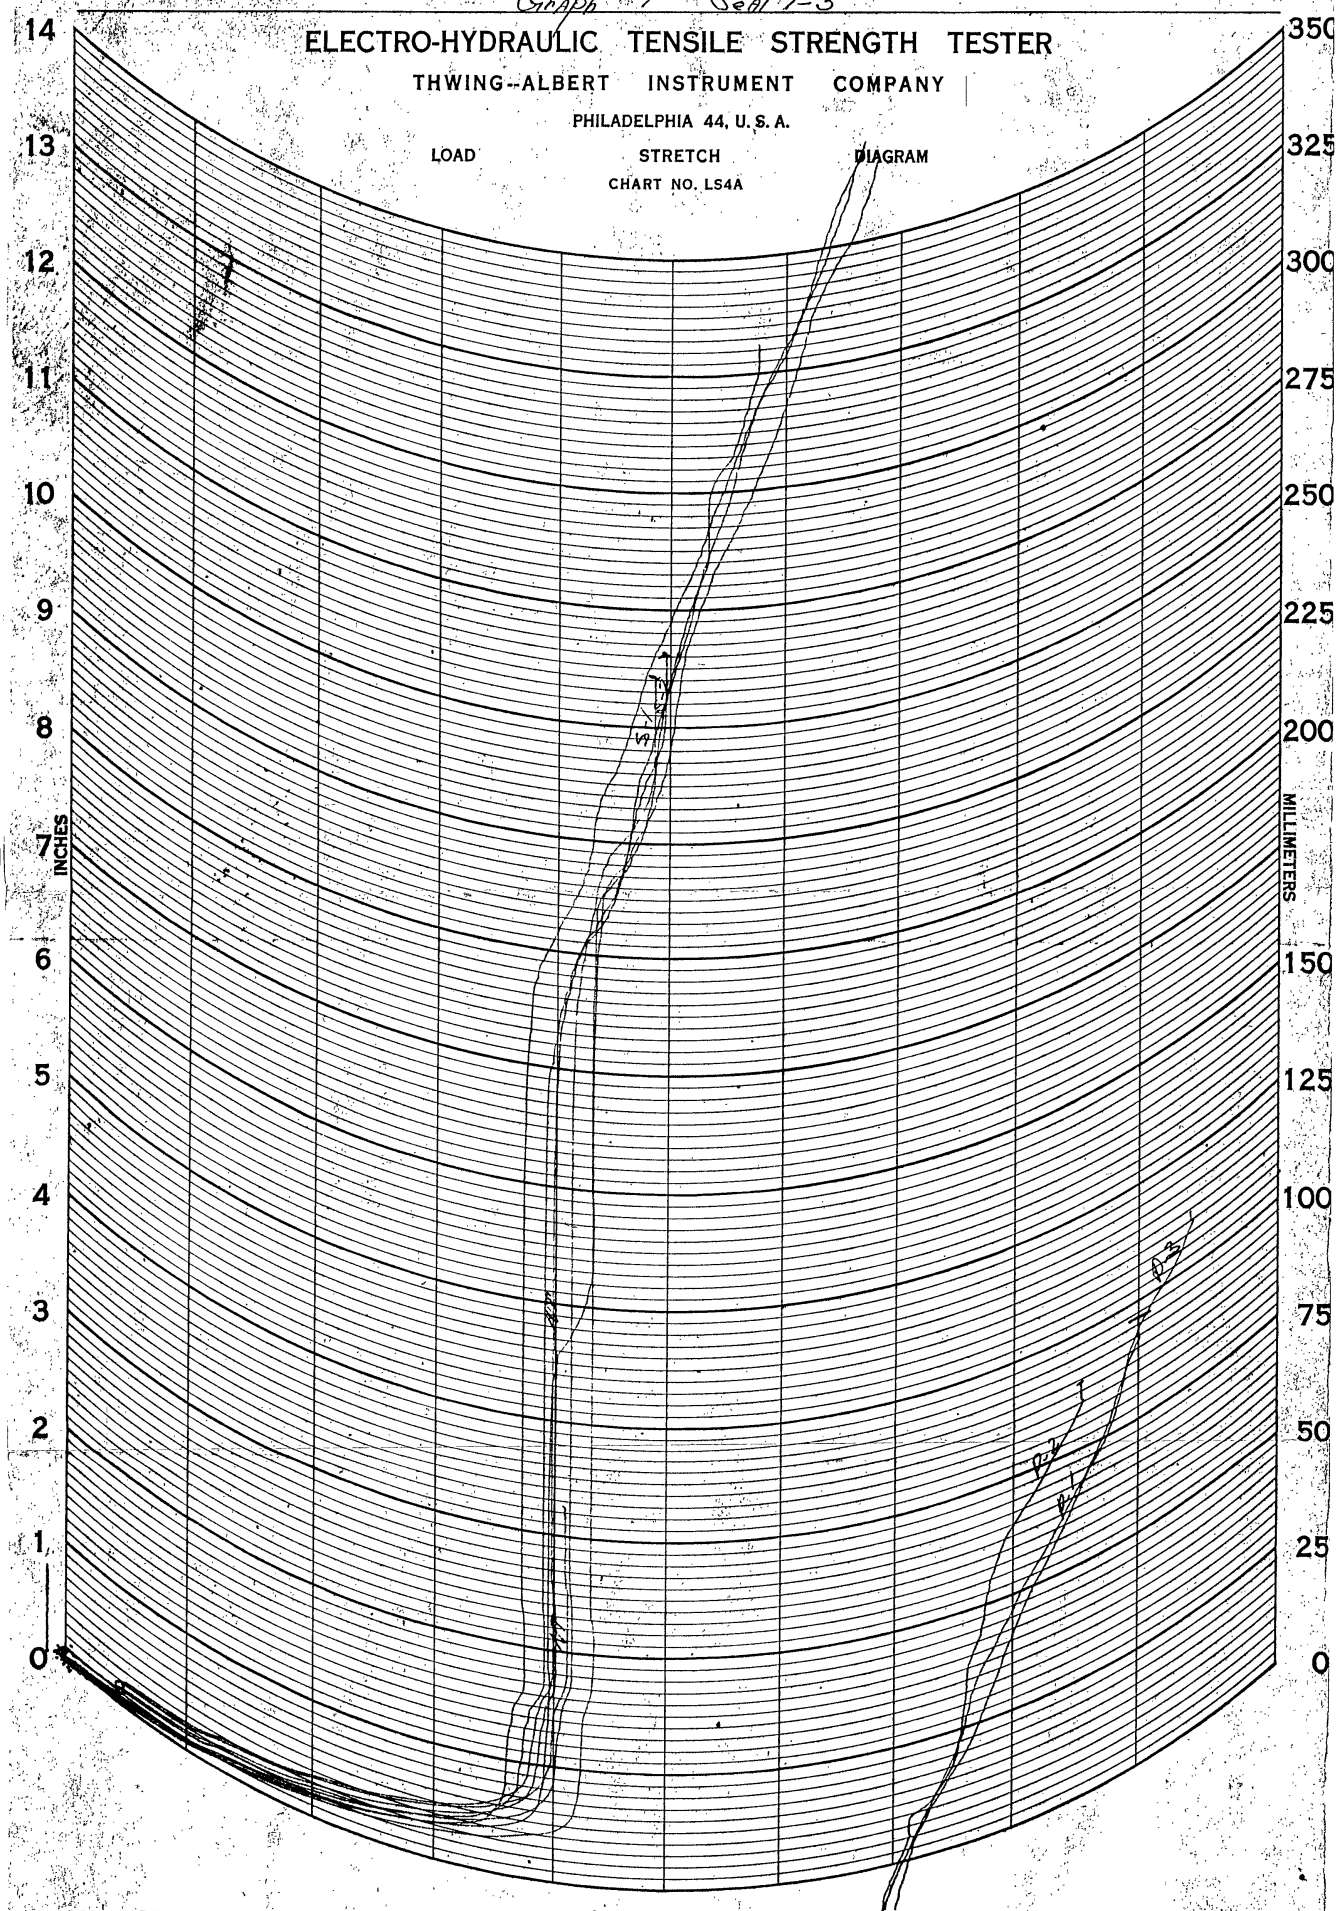
Graph #2 4-6

The attached stress-strain graphs are the results of the tensile tests of seals and parent materials. Graphs 1, 2, 3, and 4 are of tests 1-3, 4-6, 7-9, and 10-13 respectively. Test #11 was declared "no test" and re-done.
